PBY Catalina

Walk Around Number 5
squadron/signal publications

By William Scarborough
Color by Don Greer
Illustrated by Joe Sewell

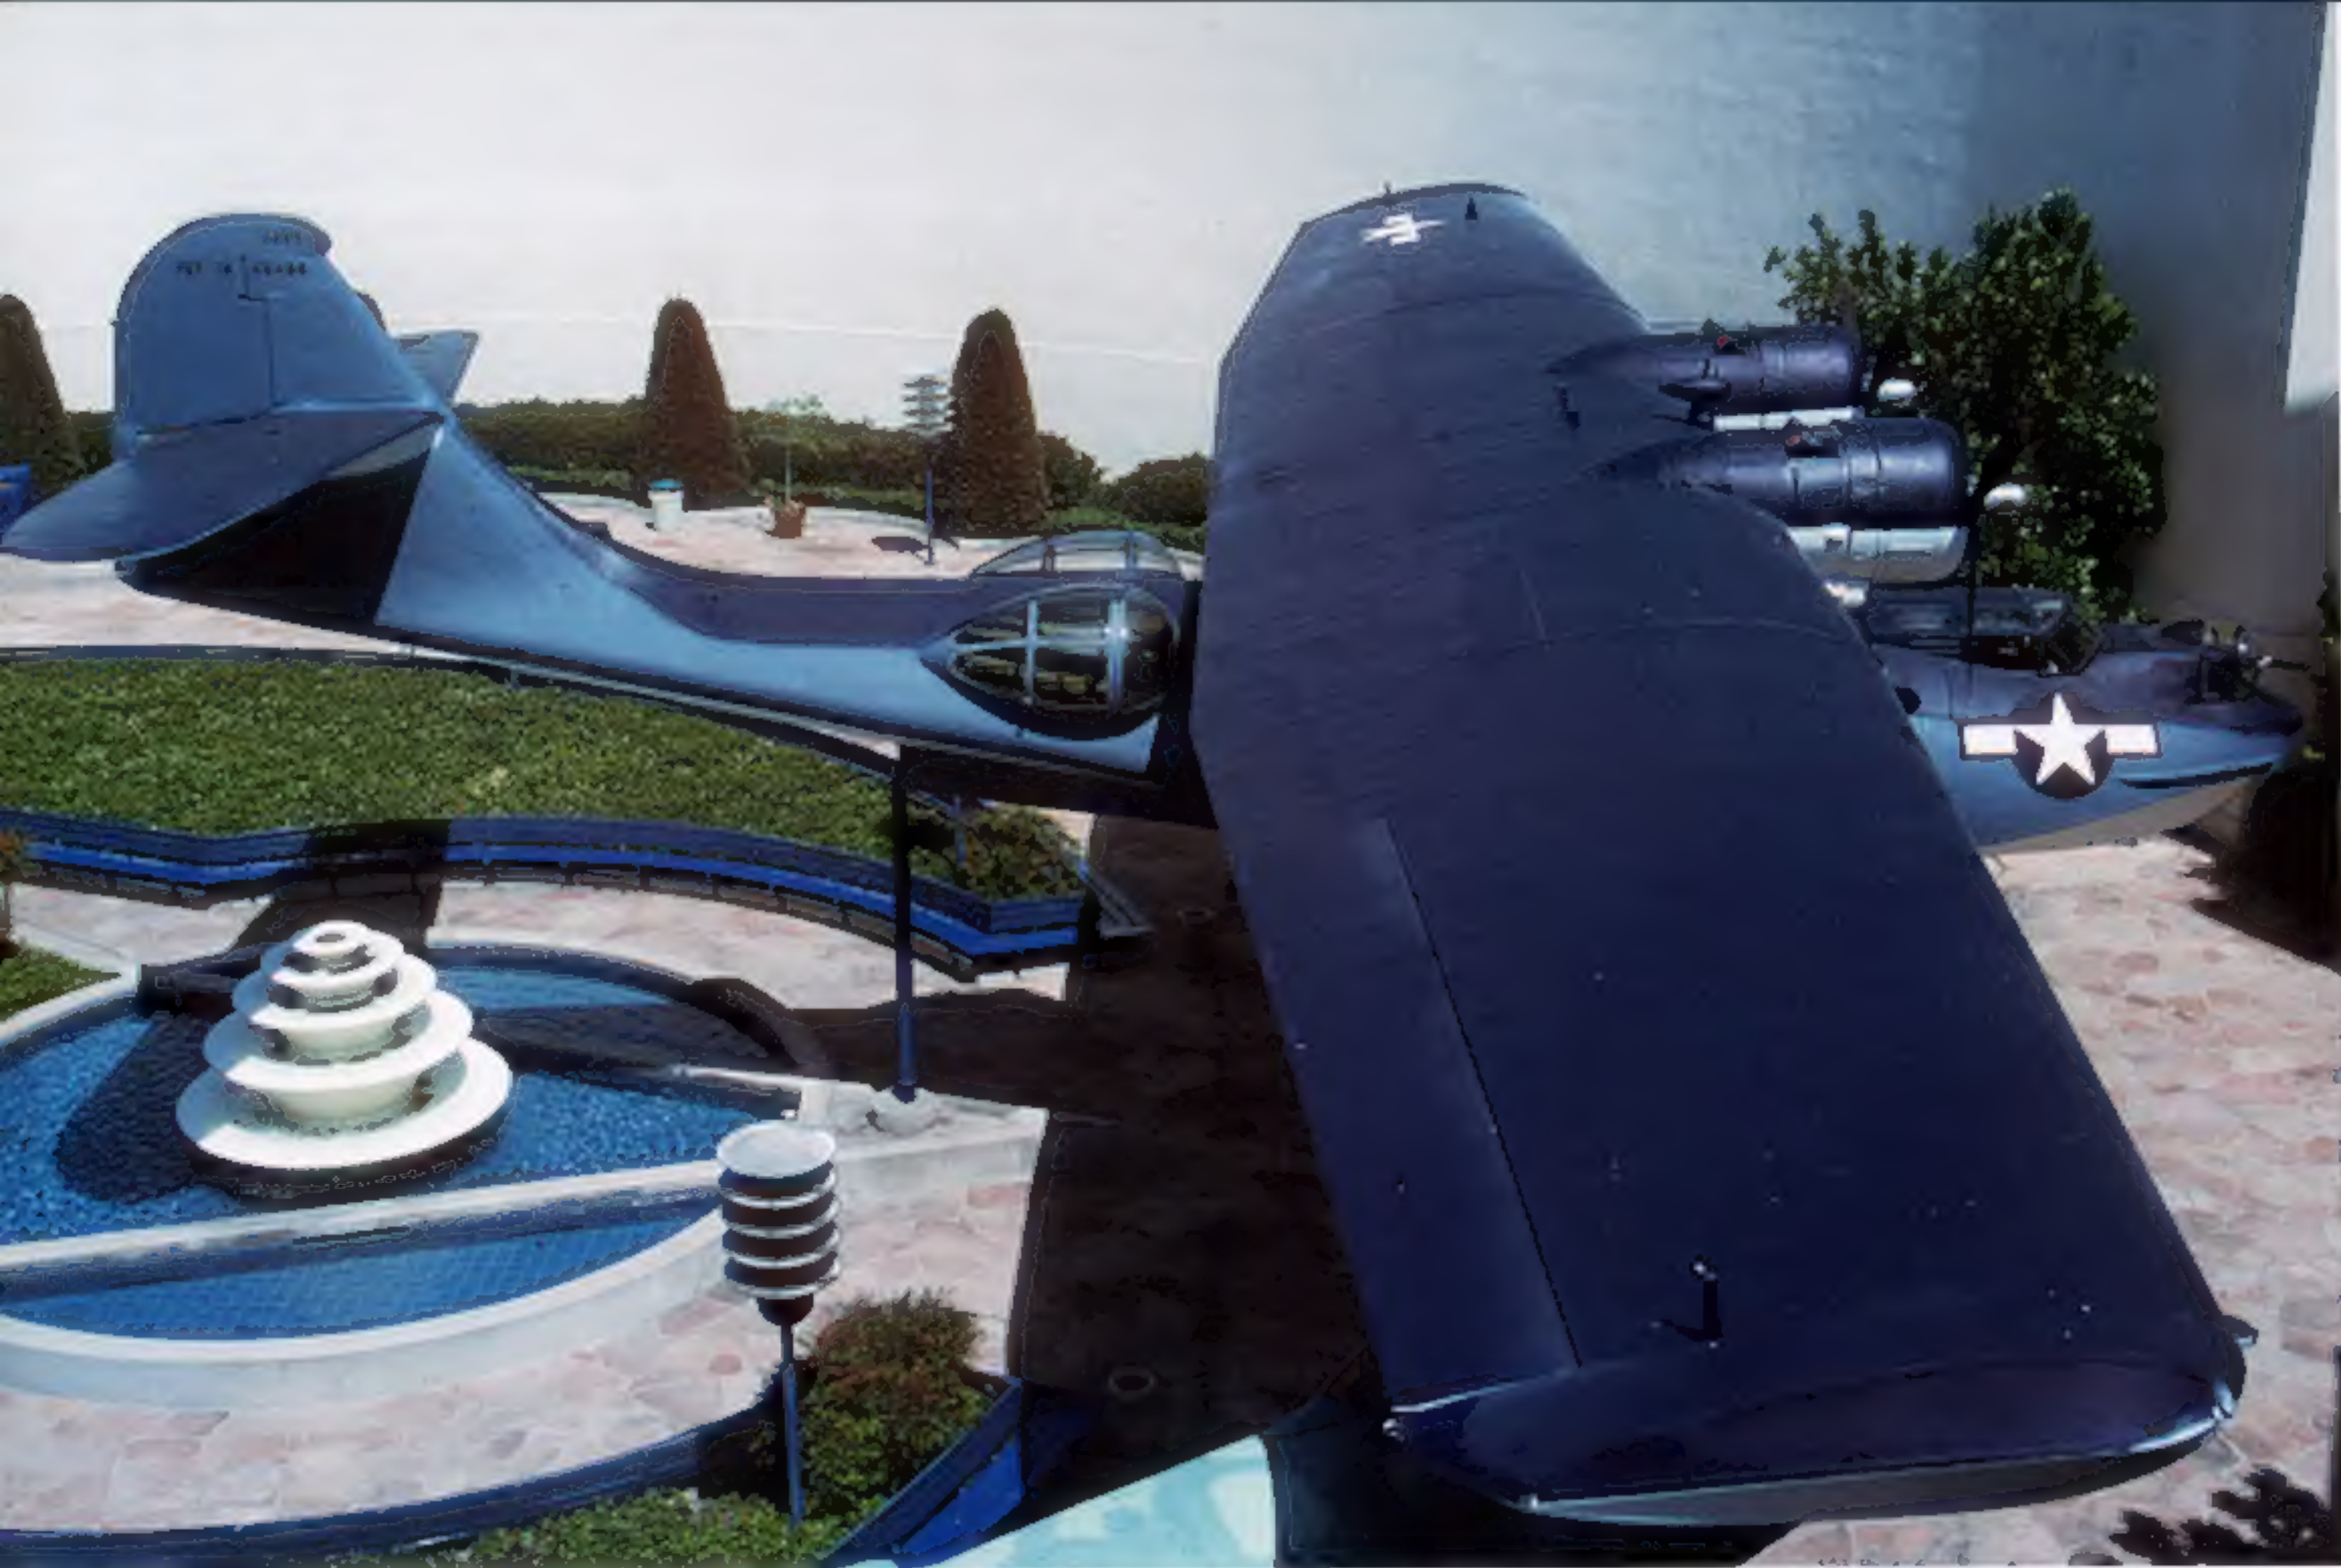
The restored PBX-5A Catalina at the San Diego Aerospace Museum is mounted on a pylon in the museum center court. From above, there are a number of details that are rarely seen including the wing tip antenna posts, wing tip lights, and tops of the engine nacelles. This PBX-5A carries a teardrop Automatic Direction Finder (ADF) antenna mounted on the upper wing between the engines. (Mark Aldrich)

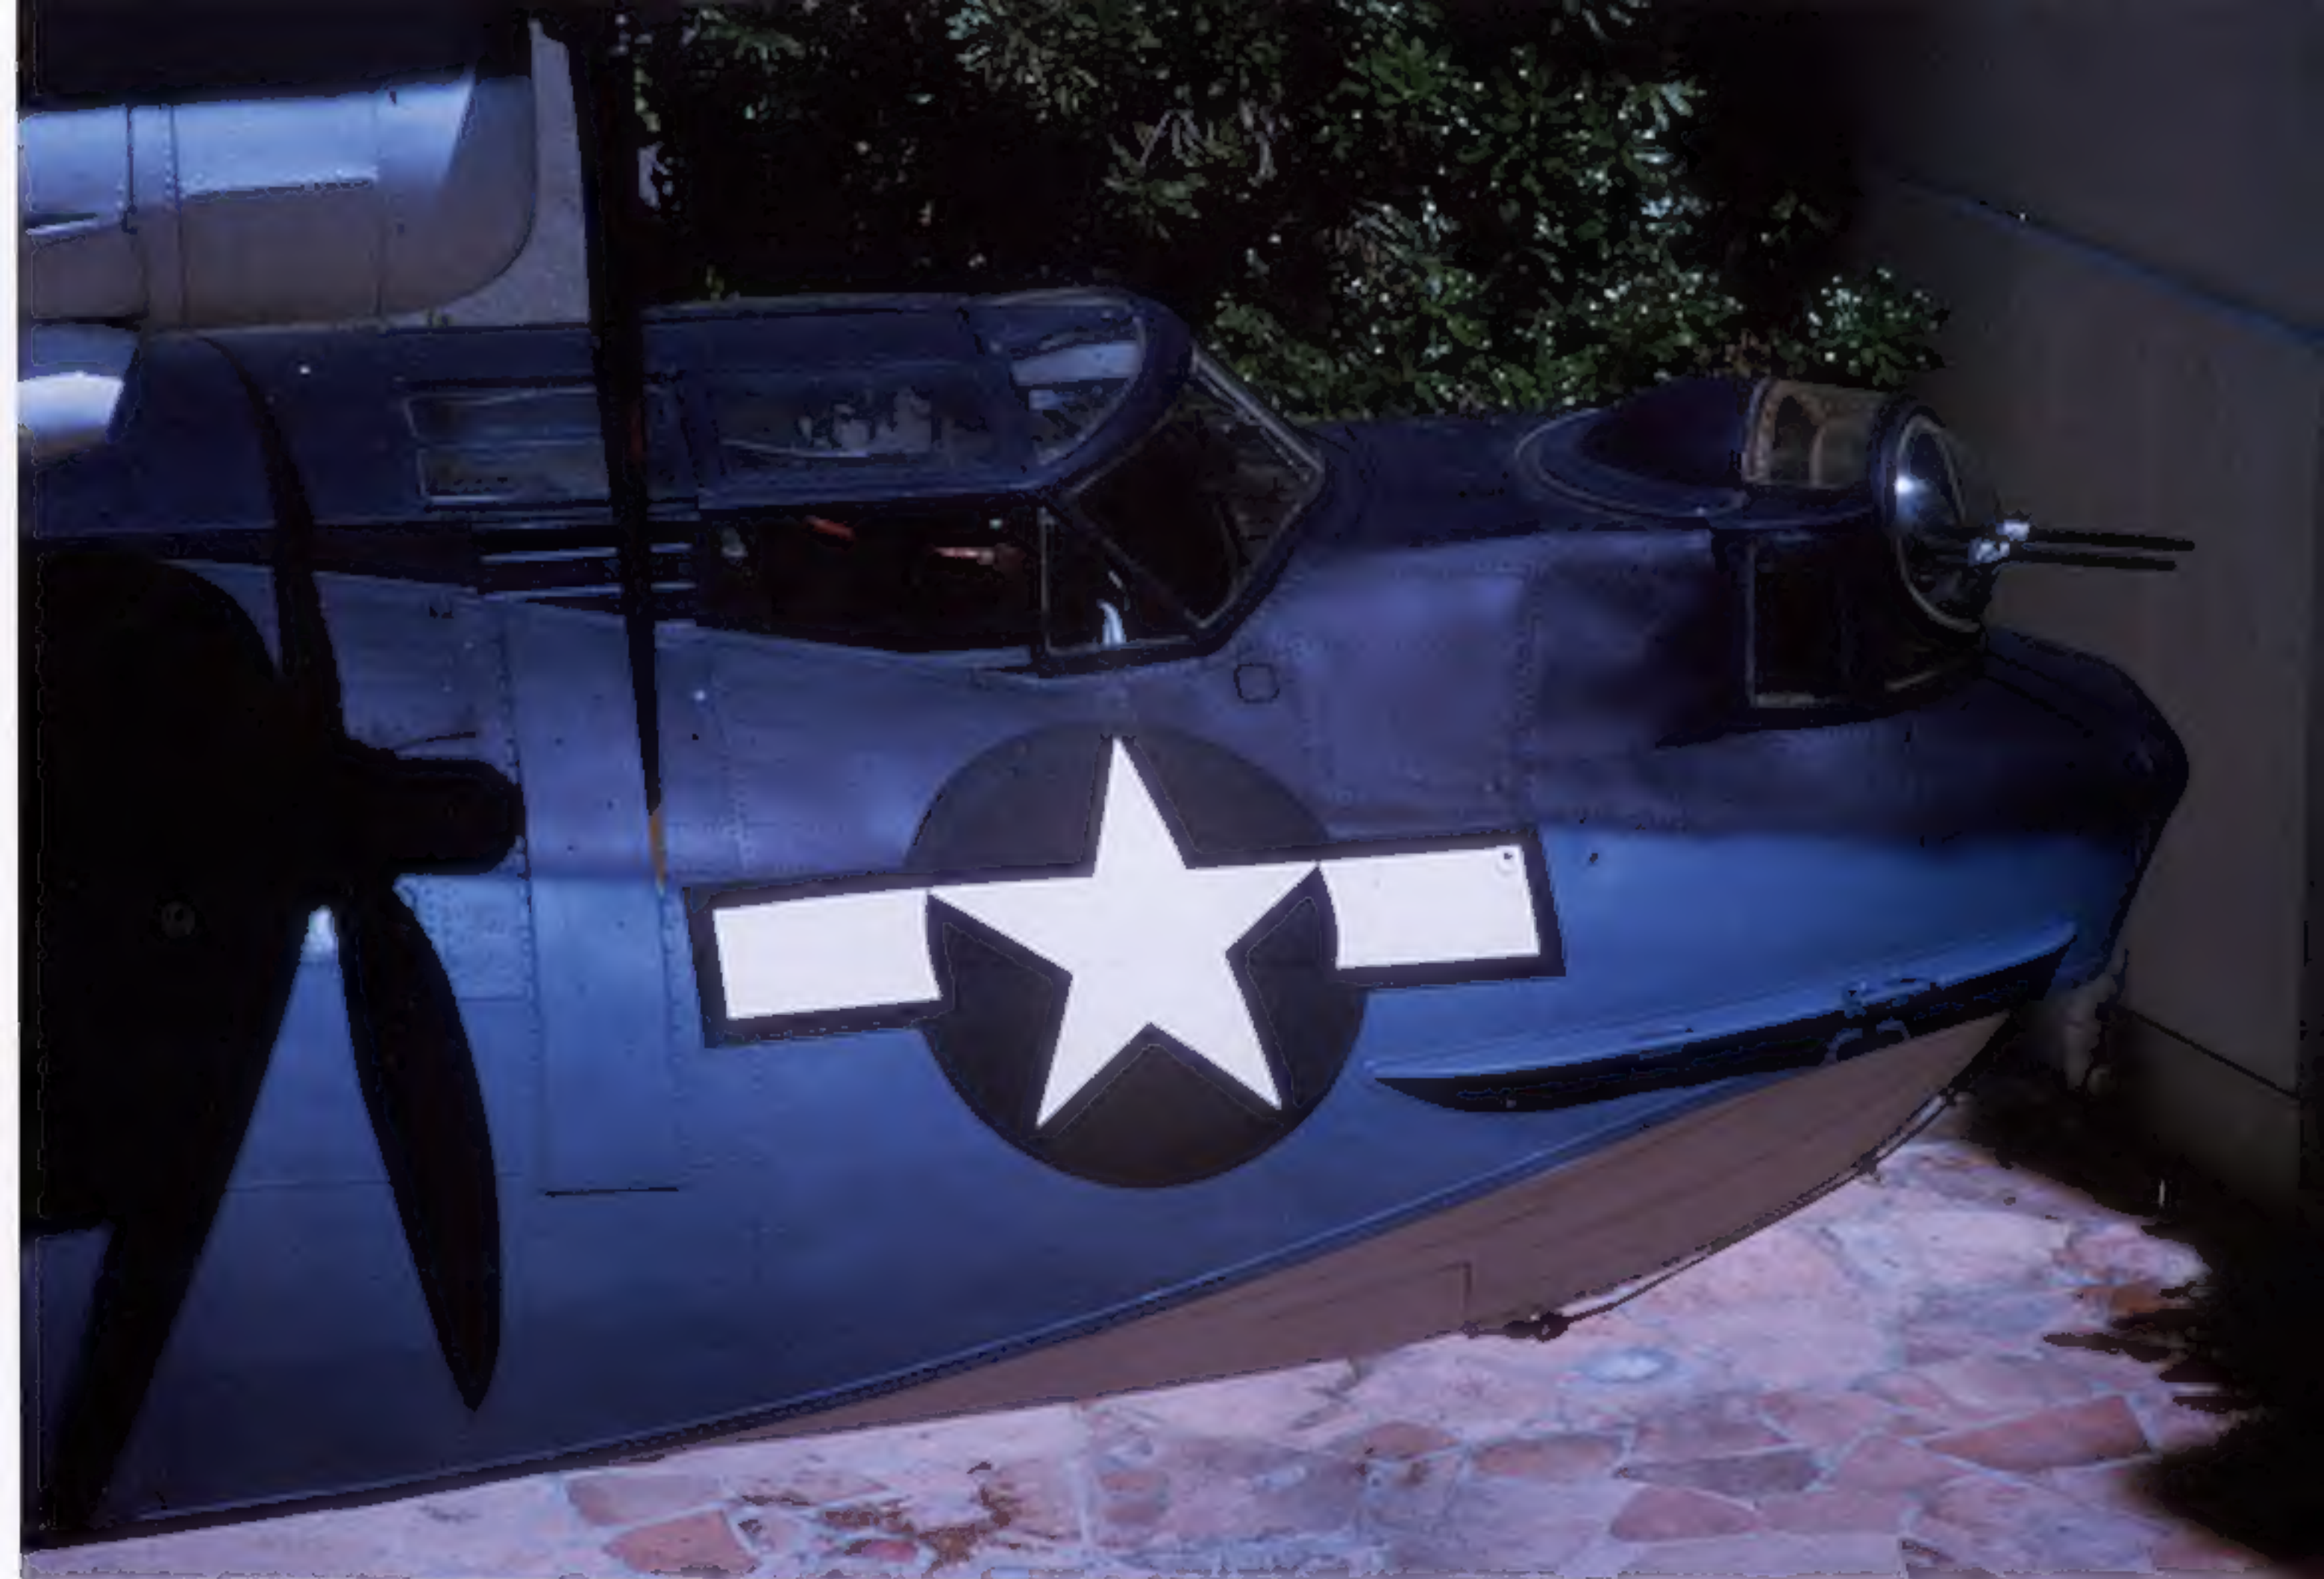
The side windows in the cockpit canopy opened and slid backward on tracks in the fuselage side for opening. The chine rail, with its mooring cleats, was used by the crew to stand on while anchoring or mooring the PBY to a buoy. The two upper canopy windows also opened, sliding to the rear. The small U shaped panel in the upper right side of the insignia bar is a pull-out step, used by the crew for climbing up on the fuselage from the chine rail. (Mark Aldrich)

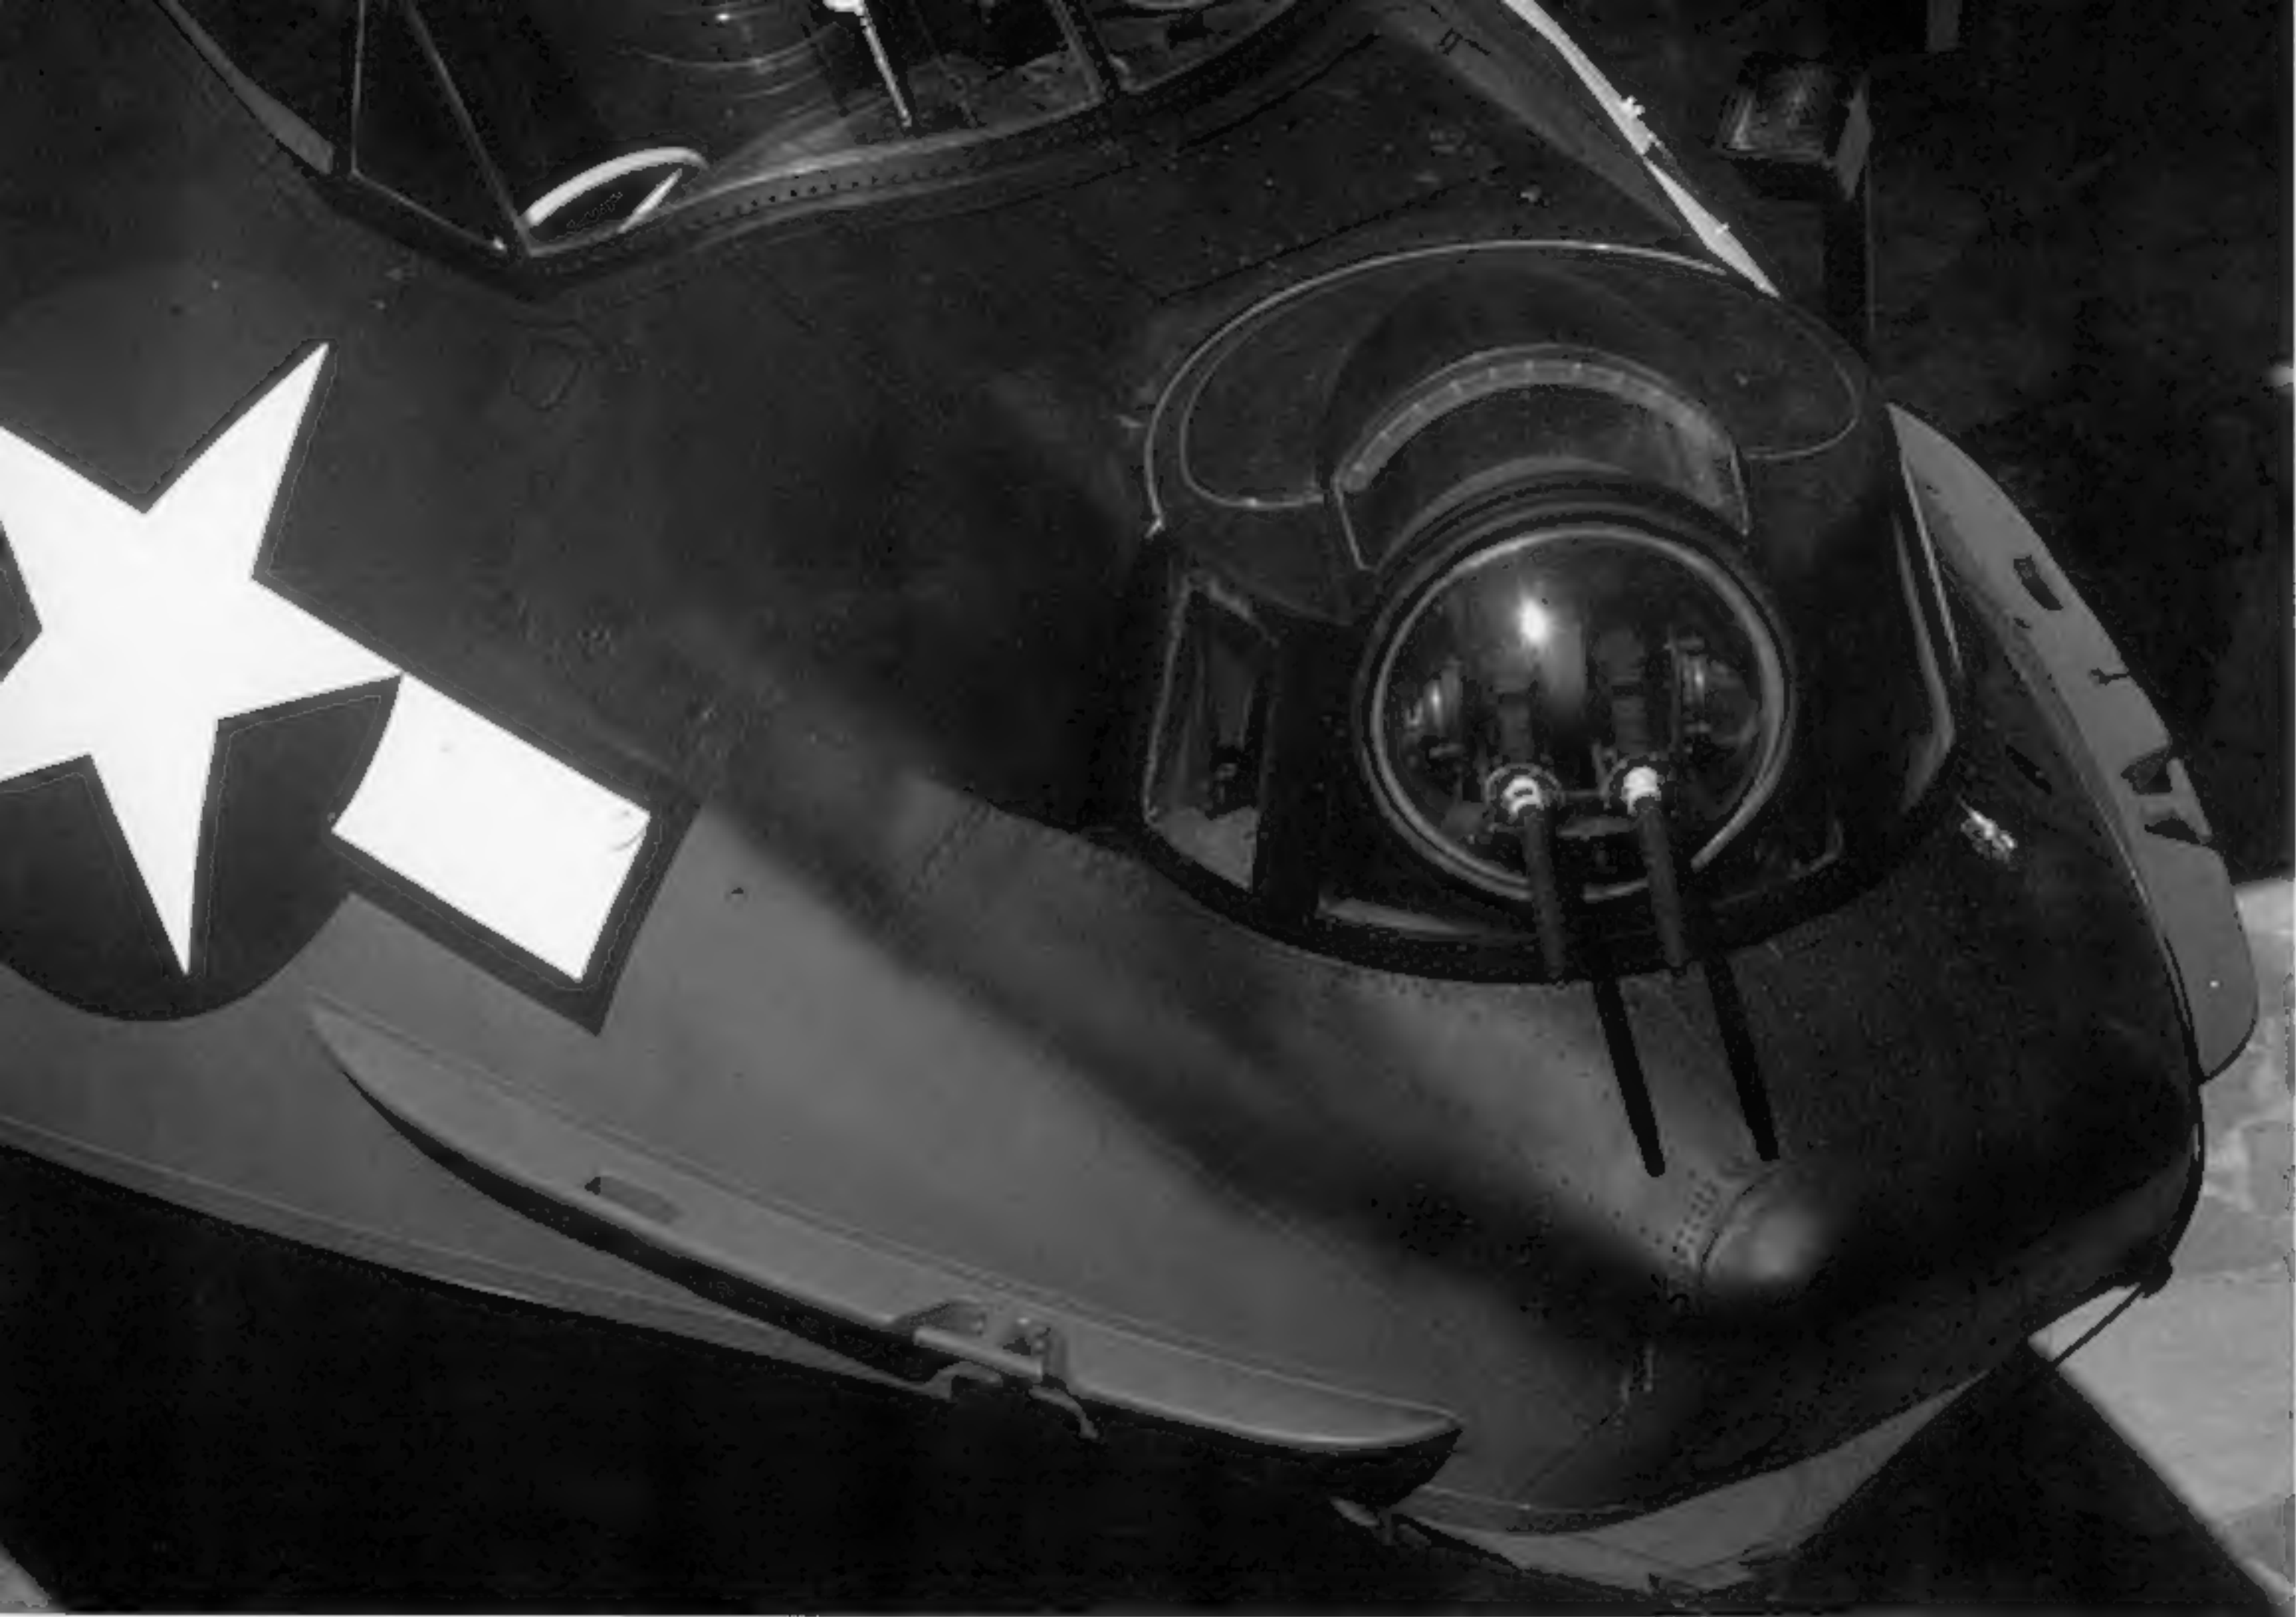
The PBV-5A Catalina on display at the San Diego Aerospace Museum carries the late war "Eyeball" twin .30 caliber machine gun bow turret. This enclosed turret replaced the open single gun position used on earlier PBV variants. Other features visible include the chine rail with its mooring cleats. (Mark Aldrich)

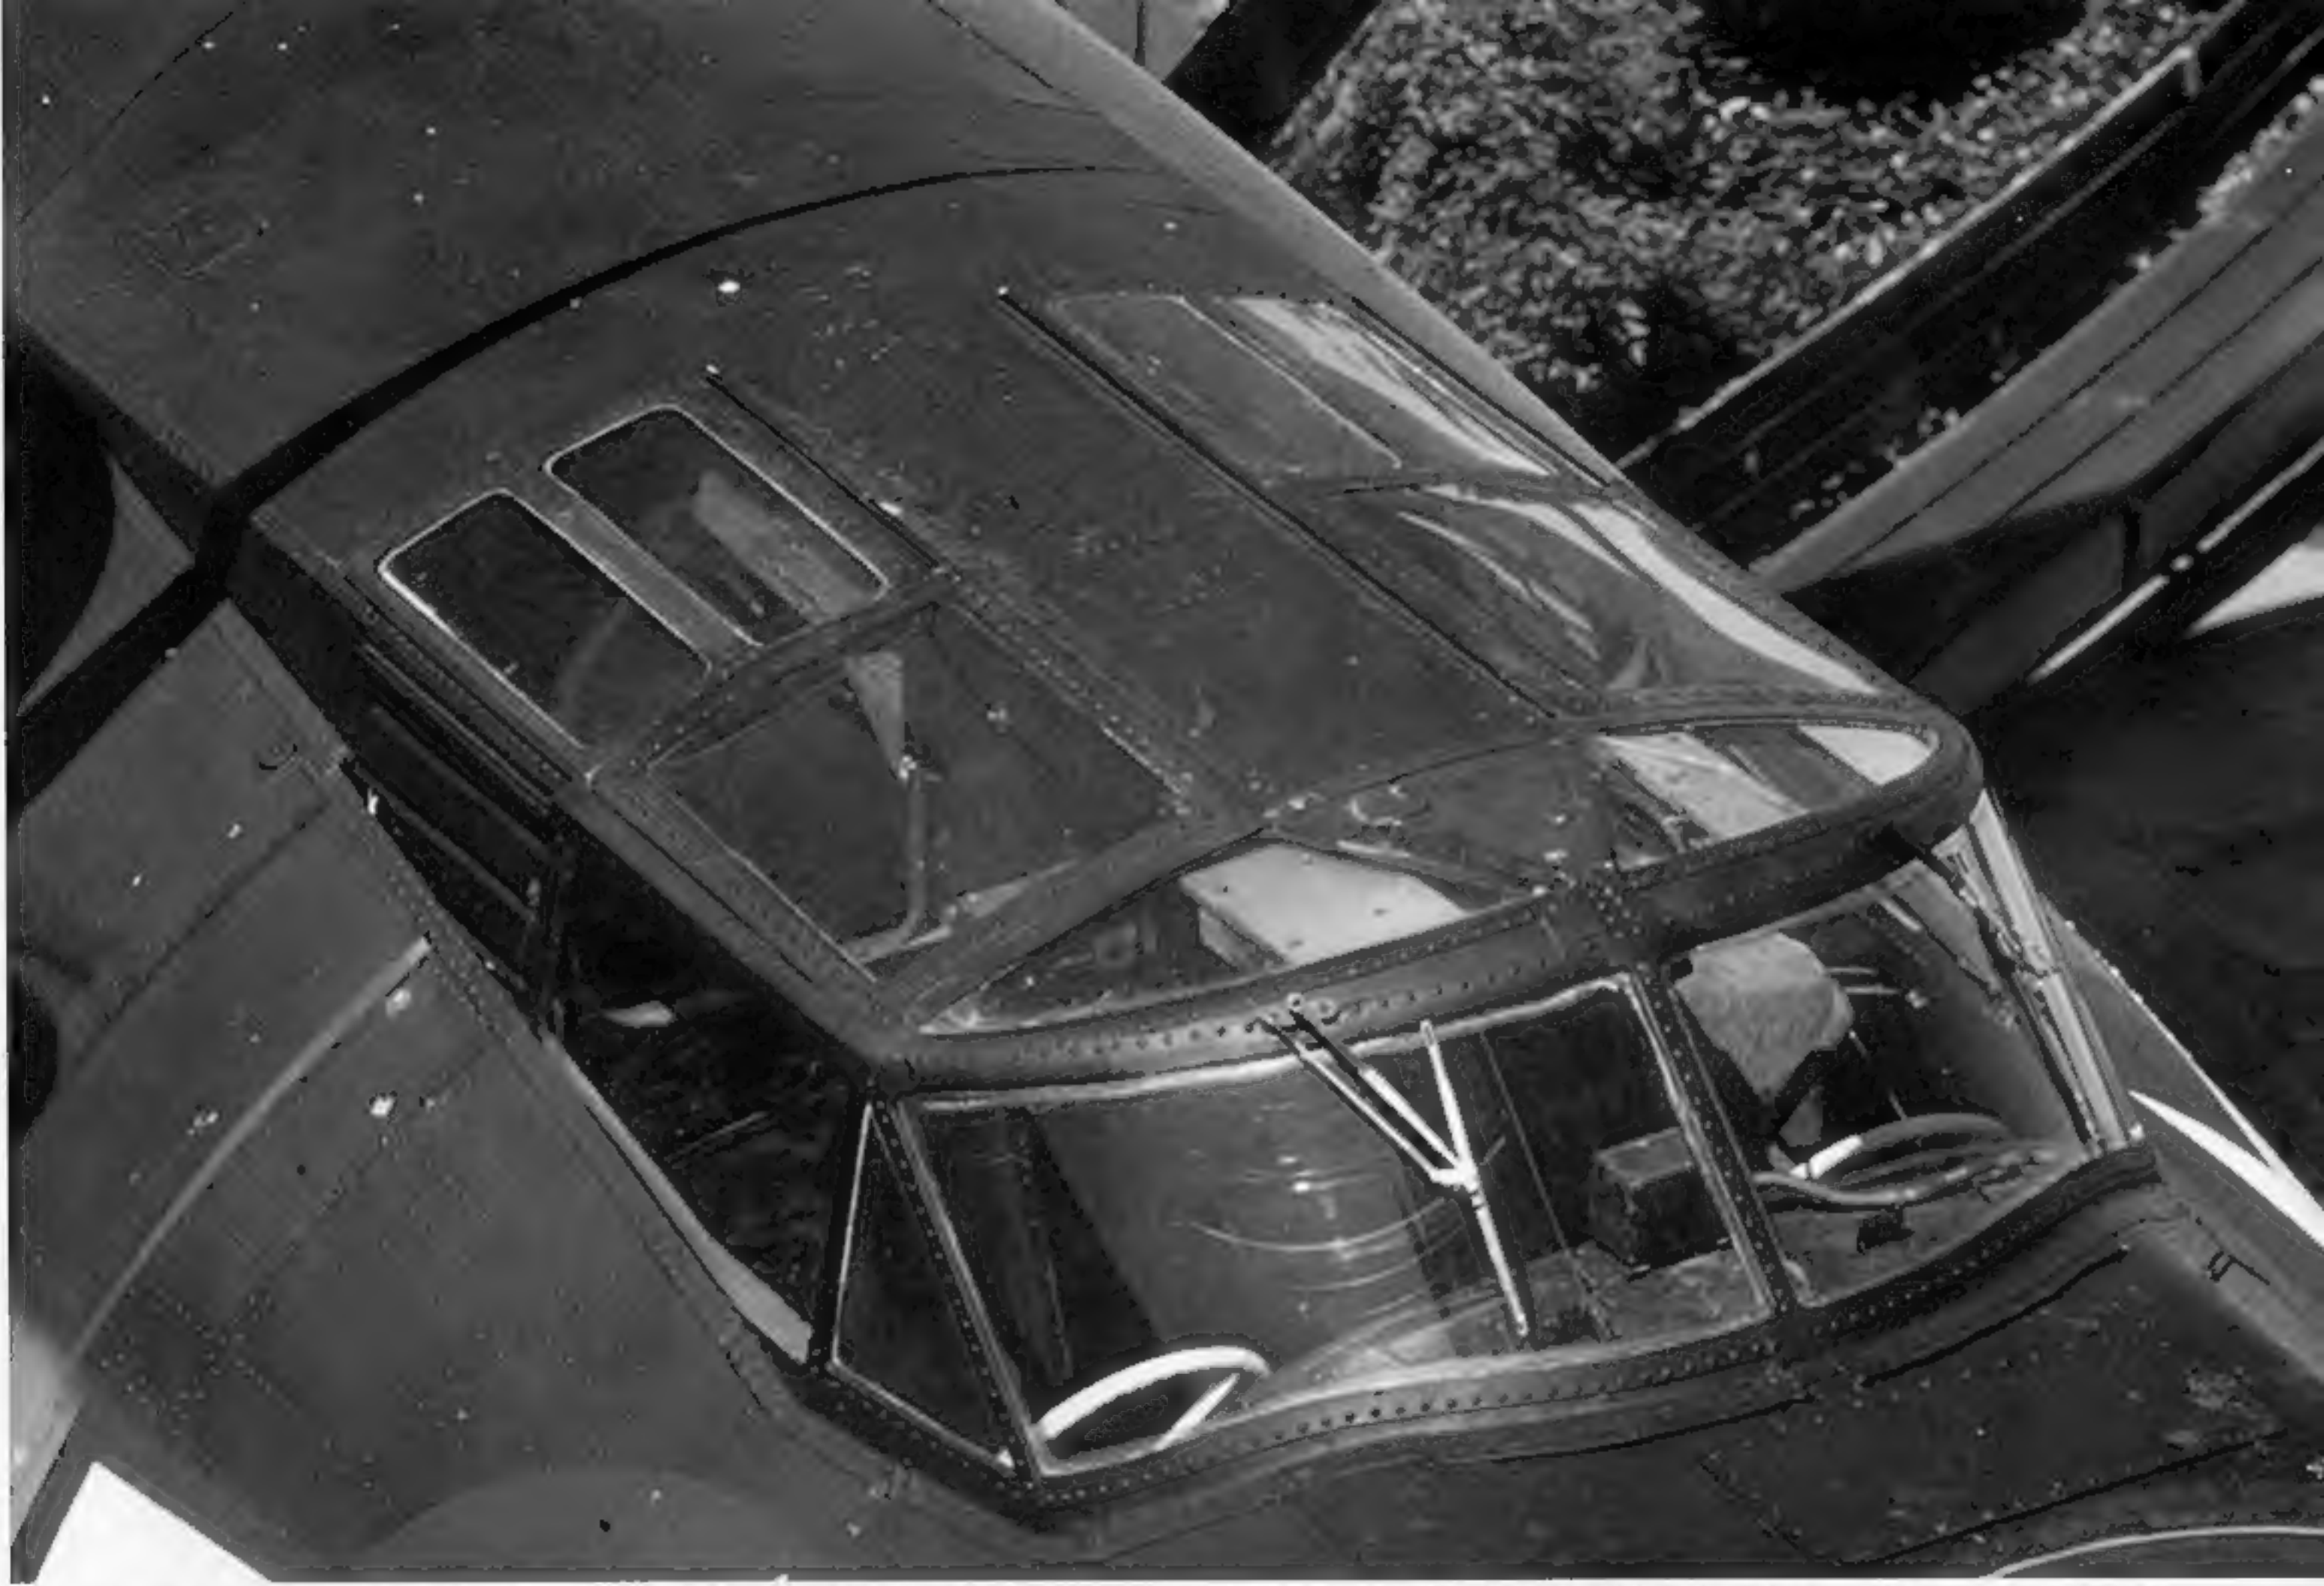
The upper canopy of the PBX-5A featured rear sliding windows on both sides that doubled as upper fuselage escape hatches. The PBX used a wheel mounted on a control yoke for aileron and elevator control. There were windshield wipers installed on both sides of the windscreen to assist in clearing away spray during water takeoffs and landings as well as in rain and during deicing. The side windows on both sides of the cockpit also opened, sliding to the rear. (Mark Aldrich)

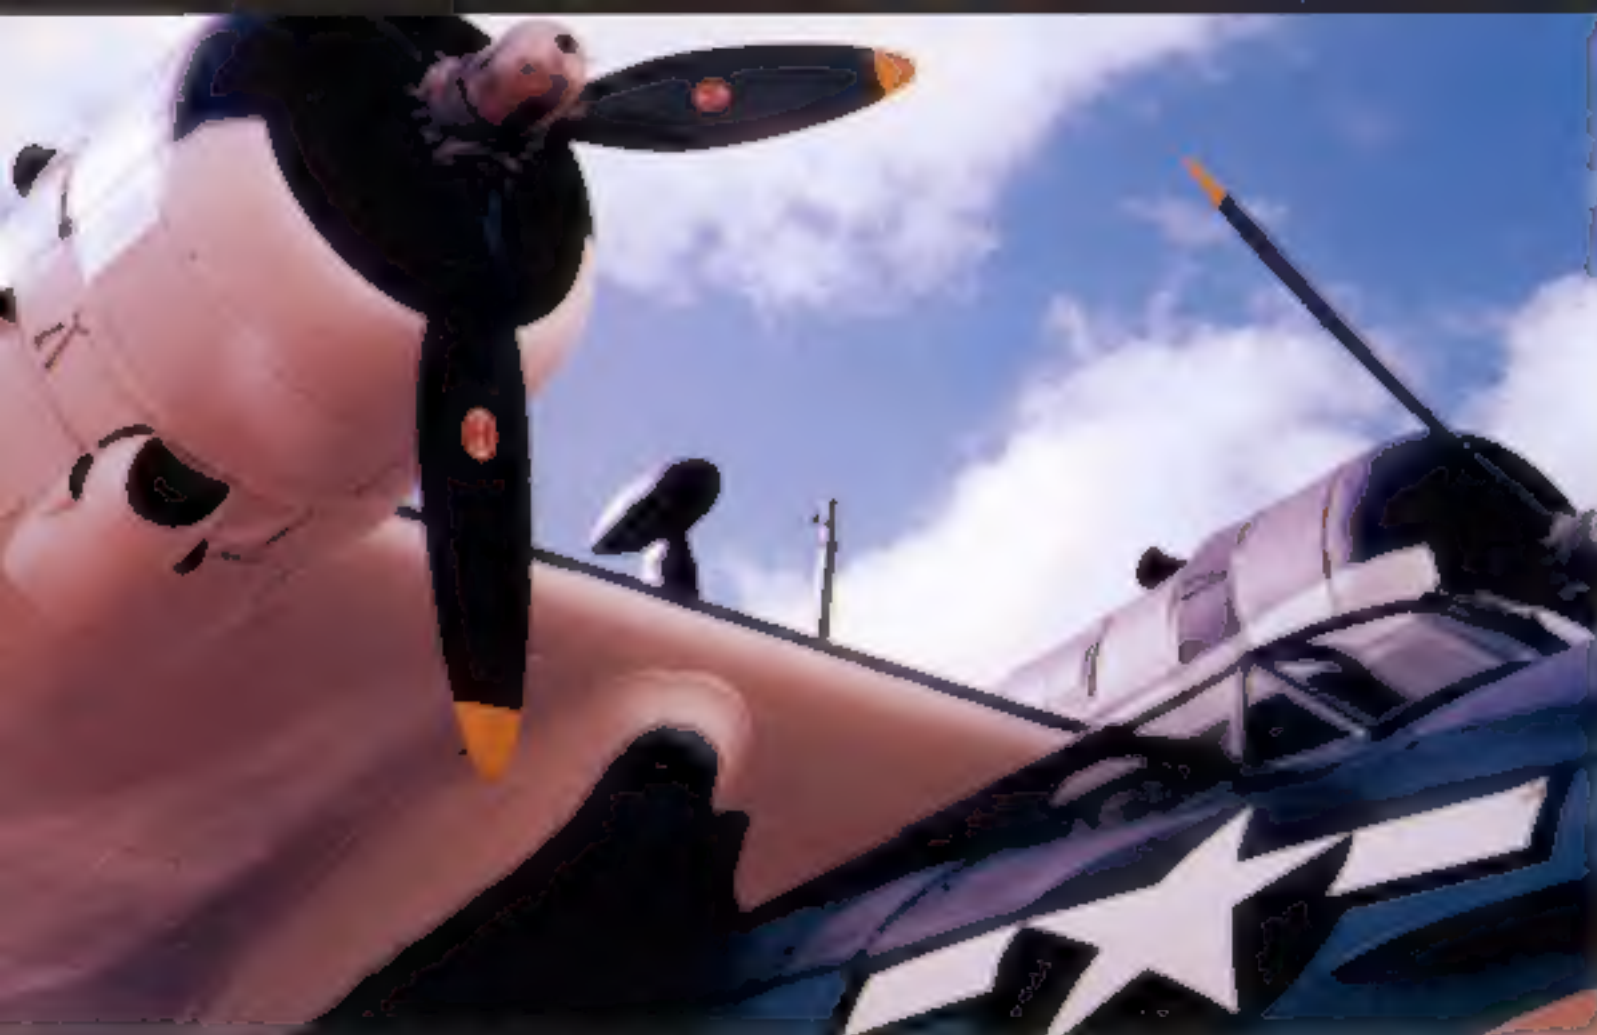
The PBY-5A at the San Diego Aerospace Museum is mounted on a pylon in the center Court. Visible are the cockpit, wing support pylon which housed a mechanic's station, wing center section and engine nacelles. An ADF teardrop antenna housing and antenna lead-in mast for the flat top antenna was mounted above the wing center section. (Richard Dann)

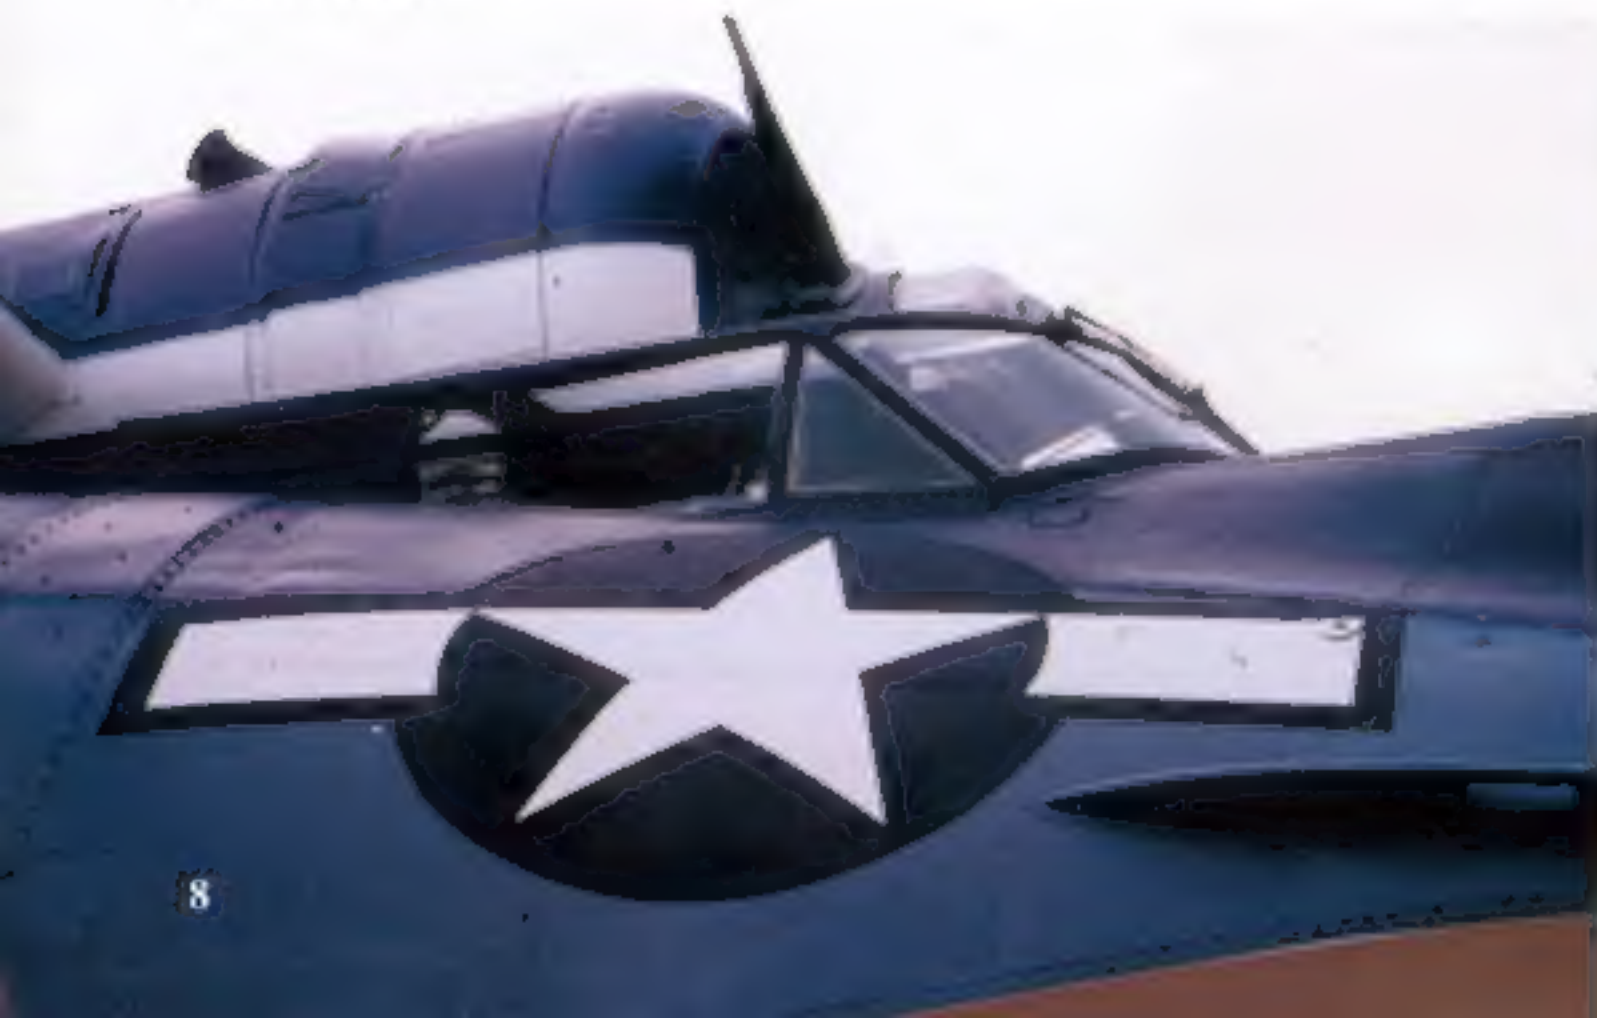
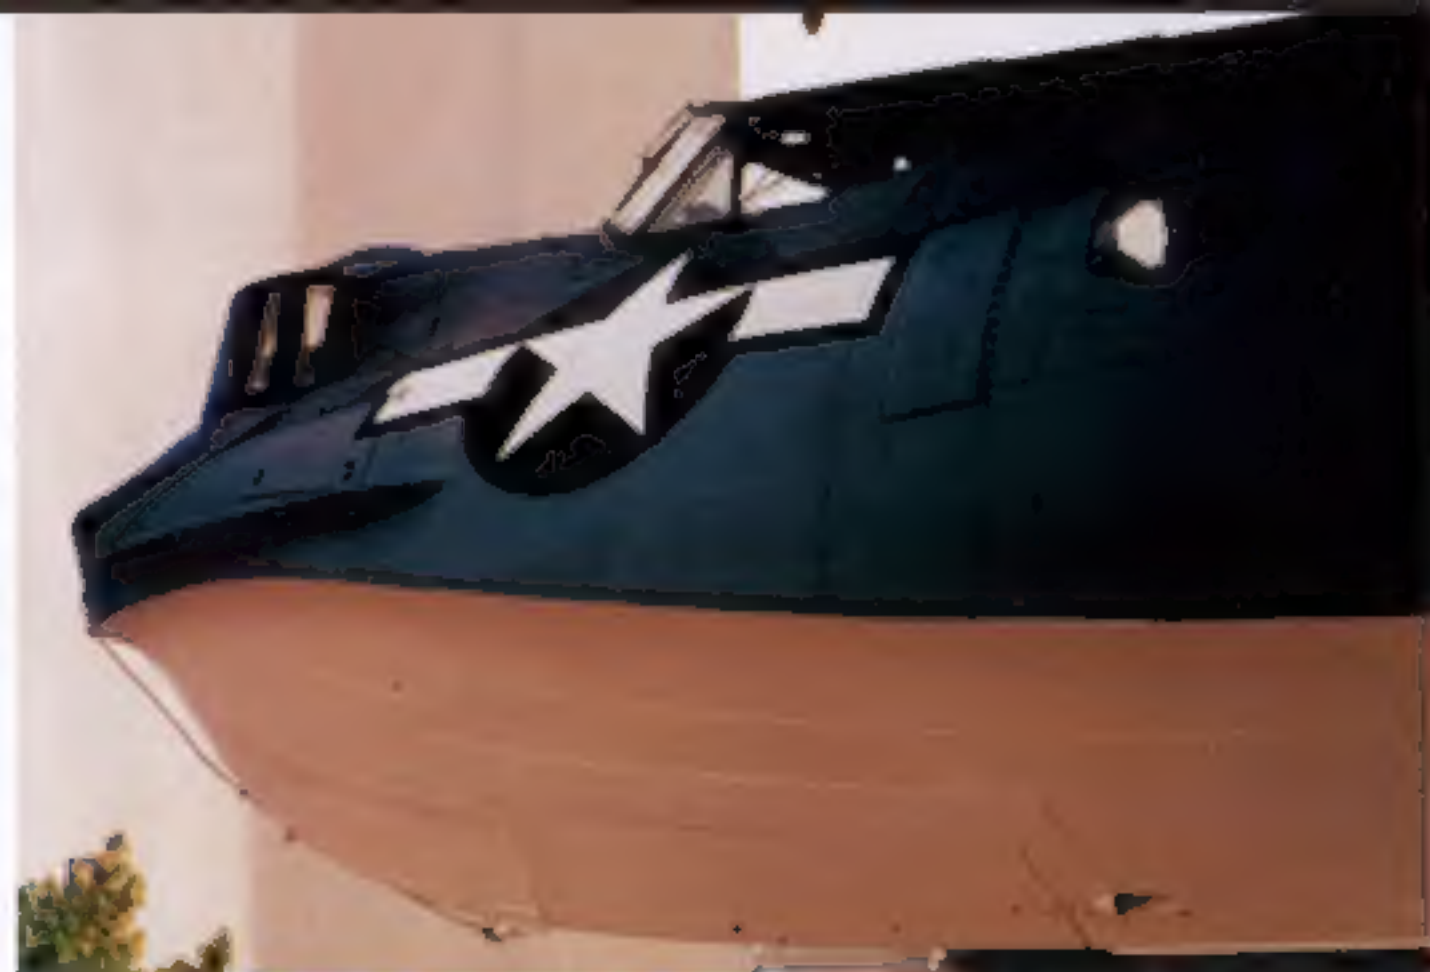
The starboard bow area of the SDAM BY-5A. From left: fuselage ice shield, which was a metal doubler to prevent damage from ice thrown from the propellers during icing conditions. The small vent at the bottom corner of the windshield can be cranked open from inside the cockpit. A pull out step is located at the upper right corner of the insignia. (Richard Dann)
